Colton Joint Unified School District Long Range Facilities Master Plan

EXISTING SITE INFORMATION

Reche Canyon Elementary School is almost completely built from modular building construction and is organized by multiple classroom wings fanning out from a central courtyard, with Cafeteria/MPR, Administration, and Library buildings anchoring the front of the school. Pairs of modular classrooms

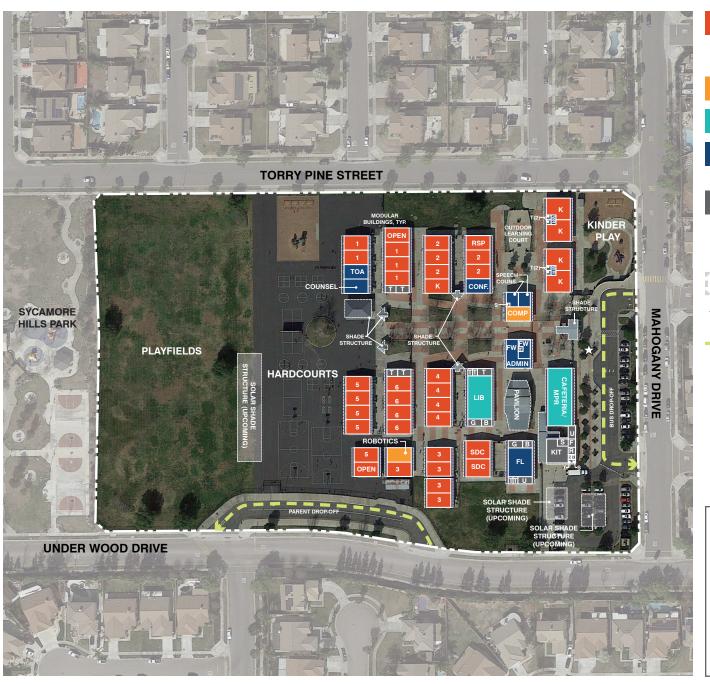
Classrooms, CR

Preschool Kindergarten

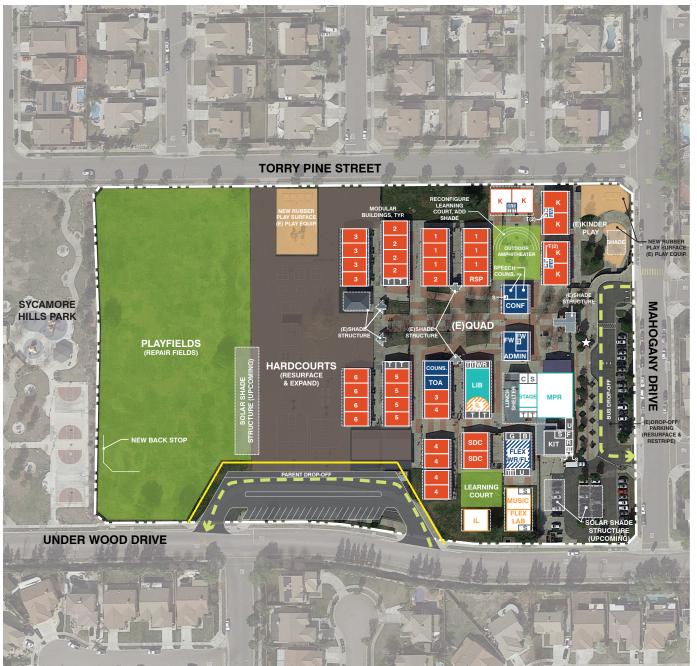
Planning Capacity:	893
Teaching Stations:	
Preschool, PK	0
TK	0
K	6
1st-3rd Grade	16
4th-6th Grade	13
Electives (1 - Flex Lab, 1 - Music)	2
Computer Lab (1 - Innov. Lab)	1
SDC (2 - MM)	2
RSP	1
Other	0
Grand Total:	41

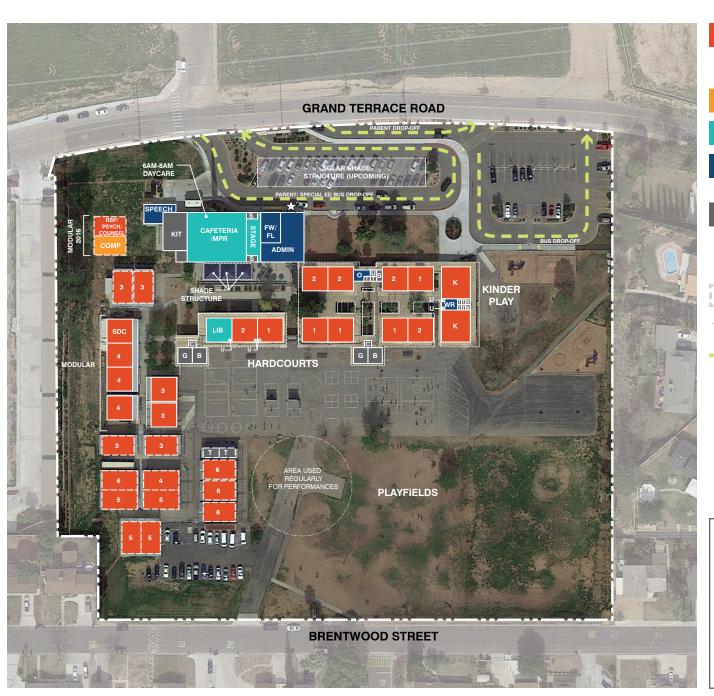
Classrooms, CR

PK Preschool Kindergarten

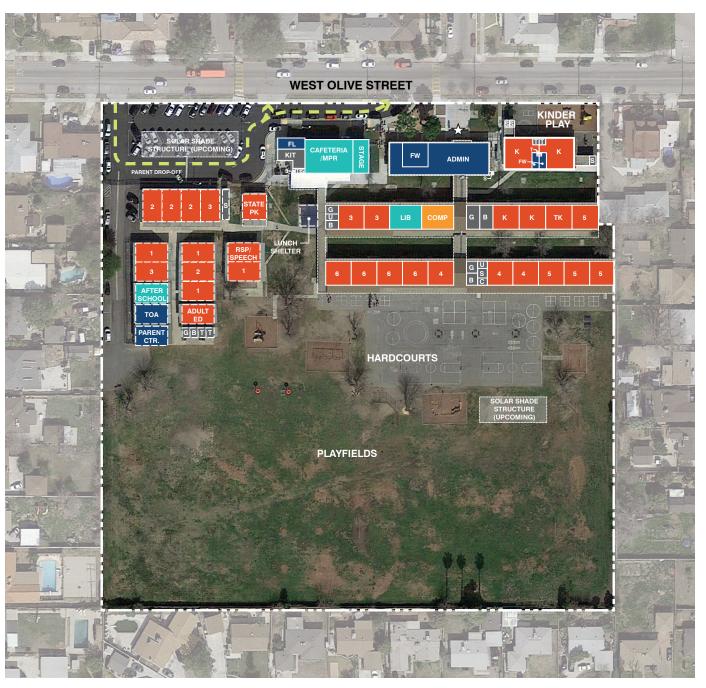
Classrooms, CR PK Preschool

Kindergarten Transitional Kindergarten Resource Specialist

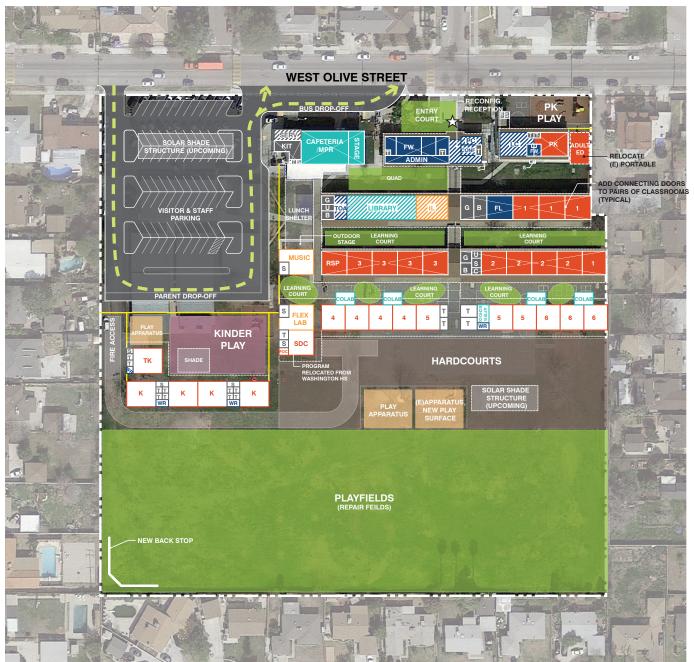
Planning Capacity:	656
Teaching Stations:	
Preschool, PK	1
TK	1
K	4
1st-3rd Grade	12
4th-6th Grade	10
Electives (1 - Flex Lab, 1 - Music)	2
Computer Lab (1 - Innov. Lab)	1
SDC	1
RSP	1
Other (1 - Adult Ed)	1
Grand Total:	34

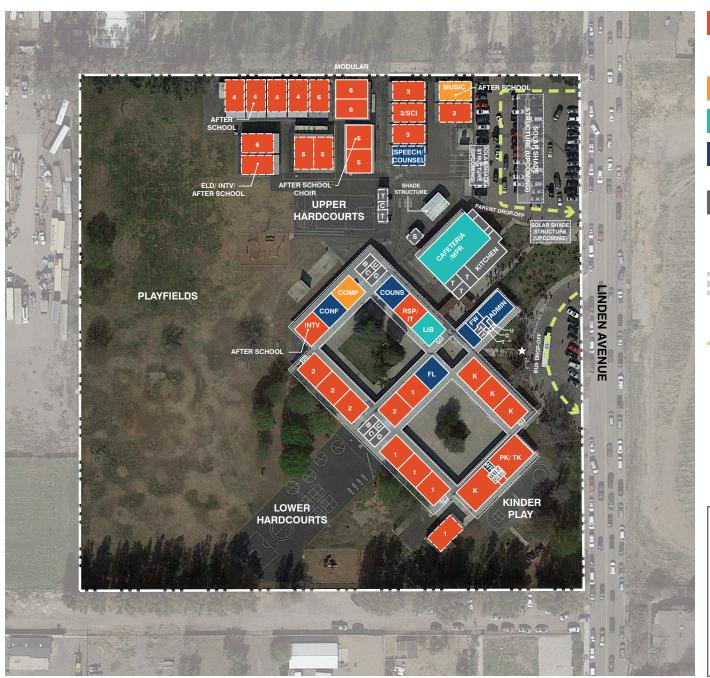
Classrooms, CR

Preschool Kindergarten

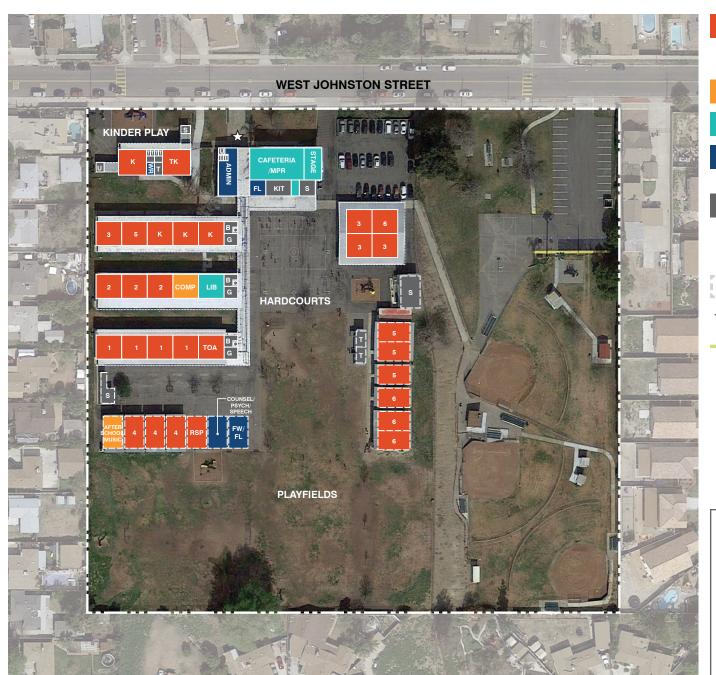
Classrooms, CR

Preschool Kindergarten
Transitional Kindergarten Resource Specialist

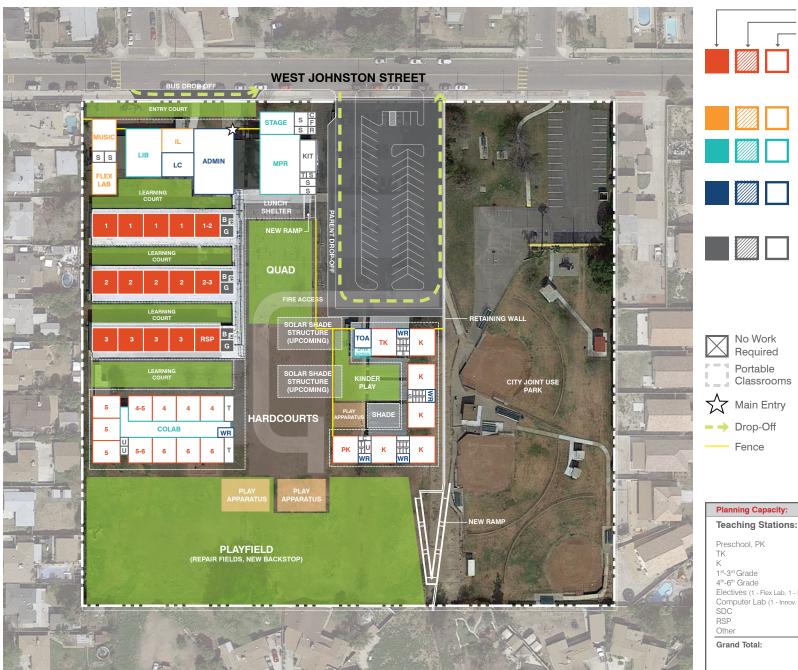
Preschool, PK	1
TK	1
K	5
1st-3rd Grade	14
4th-6th Grade	11
Electives (1 - Flex Lab, 1 - Music)	2
Computer Lab (1 - Innov. Lab)	1
SDC	0
RSP	1
Other	C
Grand Total:	36
